NAVSEA REPORT NO. S555-79
JUNE 1981

LASER TRANSFORMATION HARDENING OF FIRING ZONE CUTOUT CAMS

FINAL REPORT

A PROJECT OF THE
MANUFACTURING TECHNOLOGY PROGRAM
NAVAL SEA SYSTEMS COMMAND

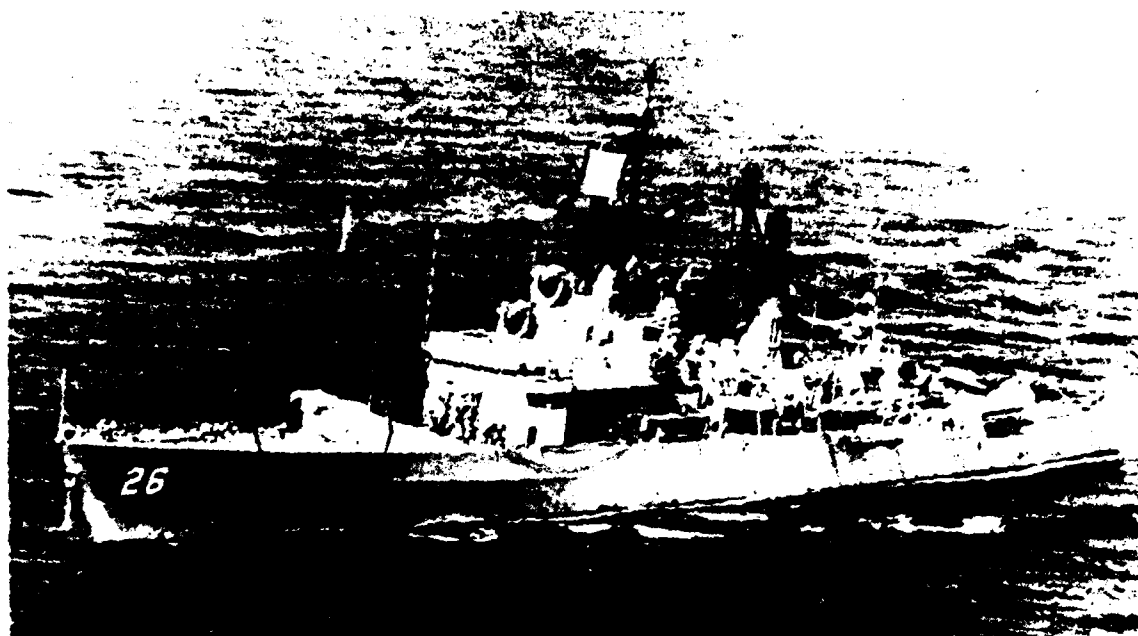
Figure 2. Photograph of USS BELKNAP (CG 26)
Showing Mk 10 Terrier Launcher (Encircled)

The Naval Surface Weapons Center (NSWC) is currently the design agent for the Mk 10 GMLS firing zone cutout cam (see Figure 1). These items are used aboard ship to confine launcher azimuth and elevation angles in order to prevent firing the missile toward ship structures. Figures 2-5 help illustrate the cam function. Figure 2 is a photograph of the USS BELKNAP (CG 26), which has a Terrier missile launcher (encircled) that uses the Mk 10 firing zone cutout cam. Figure 3, a schematic of a DDG 37 class ship, shows a missile being launched to avoid the ship's superstructure. Figure 4 provides an example of cam contour, while Figure 5 provides a schematic of a typical firing cutout zone. The contour of the cam corresponds to the nonfiring zone profile that is configured to the layout of the ship superstructure. A cam follower (contact pin), when in contact with the cam, tells the launcher not to fire.

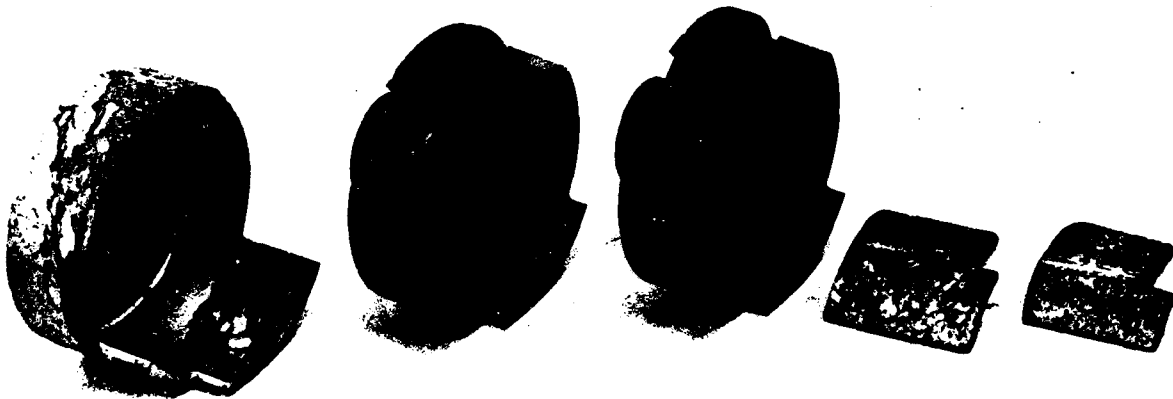
Figure 22. Cam Sections After 48-Hour Salt-Spray Test

A 48-hour accelerated corrosion salt-spray test was conducted on both nitrided and laser-treated cams and cam sections. Photographs of these sections after salt-spray testing are provided in Figures 22 and 23. Figure 23 simply shows the reverse side of Figure 22. The general result of the accelerated corrosion test was that there was no apparent difference in the corrosion resistance of the five sections shown in Figures 22 and 23. The five sections shown in these figures are nitrided nitralloy steel, parcoluberized-laser-treated 1045 and 4340 steels, and bare-laser-treated 1045 and 4340 steels.

One problem interpreting these results lies in the fact that much of the corrosion was caused by salt-spray runoff or spillage from an area where salt water collected. The corrosion appears worse than it normally would and interferes with proper interpretation. It was expected that the nitrided corrosion resistance would be better than untreated steel (non-nitrided). However, it is obvious that the nitrided cam corrodes.
